Kombi Rapper RUN/COOL-DOWN Switch Failure

Models: KRI, KRII, IC1620 with Pilot Light Switch

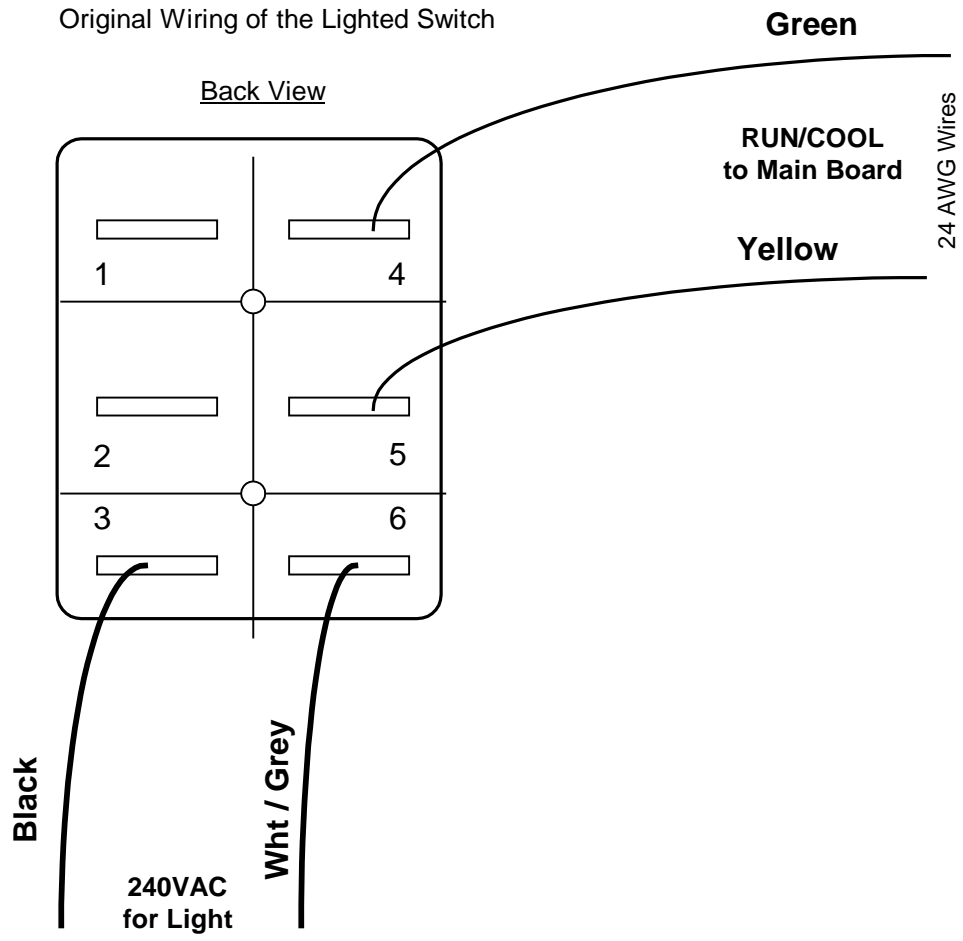
Original Wiring of the Lighted Switch

DO NOT CONNECT THESE WIRES

AFTER YEARS OF OPERATION THE SWITCH BREAKES APART AND SHORTS OUT THE LINE VOLTAGE TO THE SENSITIVE PCB CONTROL VOLTAGE RESULTING IN A VERY COSTLY CONTROL BOARD DAMAGE. IF THE SWITCH IS BROKEN AND NEEDS TO BE REPLACED ORDER THE NON-LIGHTED VERSION PN: 5420-91

DUE TO REPEATED CATASTROPHIC MAIN BOARD FAILURE FROM FAILING RUN-COOL DOWN SWITCH, WE HIGHLY RECOMMEND TO IMMEDIATELY DISCONNECT THE LIGHT WIRES AND INSULATE.

INSTALL A SEPARATE PILOT LIGHT IF DESIRED
